# Evaluation of Obturator and Sealing Cuff Properties for the M865 Training Projectile With Comparison to Ballistic Testing

by C. P. R. Hoppel, J. F. Newill, and K. P. Soencksen

ARL-TR-2039 September 1999

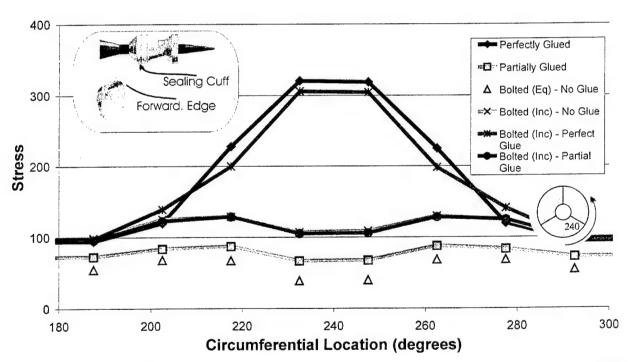
Figure 12. Stress Distribution at the Forward Edge of the Sealing Cuff During Sabot Discard.

with a bolted sealing cuff. The stress distributions at the leading edge of the sealing cuffs during discard for these cases are shown in Figure 12 and Figure 13. When the sealing cuff is perfectly bonded to the sabot, the stress is focused at the seam between the petals. This provides a short gauge section for failure between the petals. When the sealing cuff is only partially bonded or not bonded, the circumferential stress is no longer focused between petals and a much larger section of the sealing cuff can deform prior to failure. Since the sealing cuff is an elastomer, it can endure substantial deformation and absorb significant energy before it breaks, increasing the chance for irregular failure. Therefore, a poor bond between the sabot and the sealing cuff can lead to less repeatable discard behavior, inducing variability that may contribute to poor Target Impact Dispersion (TID). When the sealing cuff is bolted to the sabot, the failure of the sealing cuff/sabot bond is less dramatic. The bolts act as secondary stress concentration sites, initiating failure if the adhesive fails. The bolts therefore help reduce the potential variability due to poor bonding.

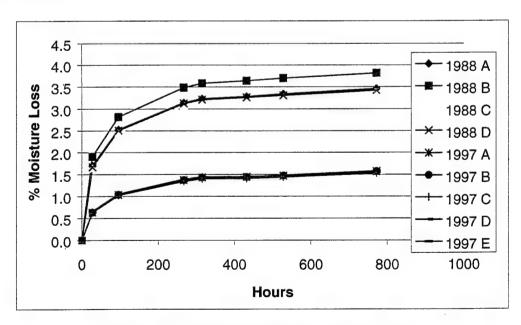
Figure 14. Obturator Moisture Loss vs. Time.

The projectiles were dried in an oven at 165° F for 32 days. The percent moisture loss vs. time is shown in Figure 14. The specimens from 1988 showed an average of 3.52% moisture loss by weight; the specimens from 1997 showed an average of 1.56% moisture loss by weight. Based on this study, it was determined that a reasonable moisture level for the "wet" obturators was 3.5% by weight moisture.

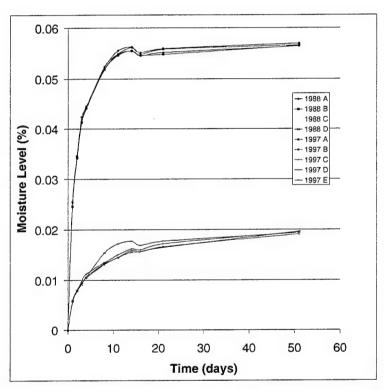
Figure 15. Percent Weight Gain vs. Time for Obturators Conditioned at 50% RH (Specimens 1988 C, 1988 D, 1997 C, 1997 D, and 1997 E) and 90% RH (Specimens 1988 A, 1988 B, 1997 A, and 1997 B).

Moisture absorption tests were then initiated to determine the moisture saturation level and diffusion constants on the obturators. The obturators from the dry-out study were placed in two humidity chambers (50% RH and 90% RH) at 145° F. The percent weight gain vs. time is shown in Figure 15. The specimens conditioned at 90% RH had an average moisture saturation level of 5.67%. The specimens conditioned at 50% RH had an average saturation level of 1.93%.

From this study, it was interpolated that obturators with 3.5% moisture content would be in equilibrium in 75% RH air. It also showed that at 145° F, the obturators reached equilibrium moisture content within 20 days.
